HAMMONTON LAKE DAM NJ 00476

PHASE 1 INSPECTION REPORT NATIONAL DAM SAFETY PROGRAM.

Hammonton Lake Dam (NJ-00476). Atlantic
Ocean Basin. Hammonton Creek, Atlantic
County, New Jersey. Phase 1 Inspection Report.

August 1979

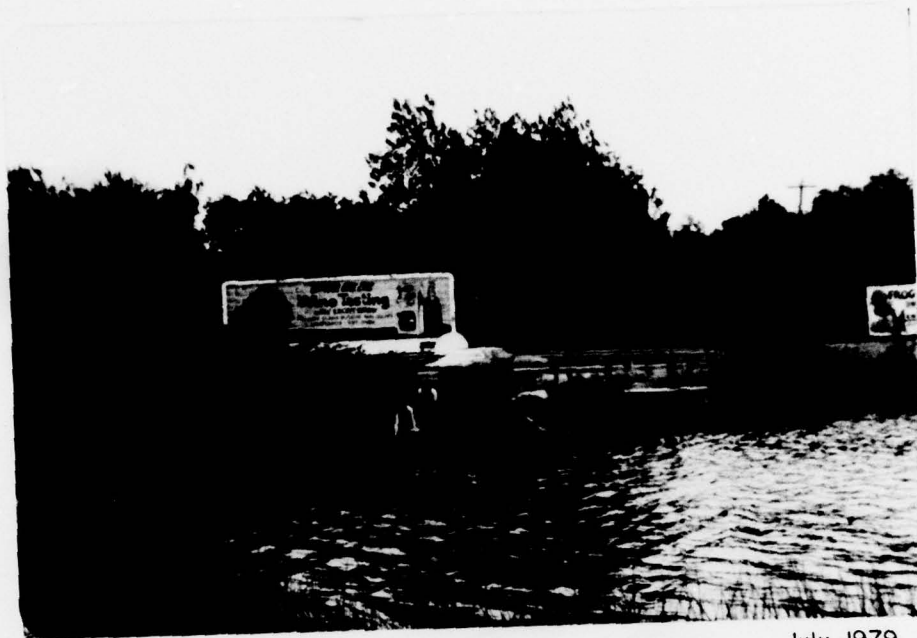
Although no design computations were available, the concrete spillway culvert is of modest span and displays only minor cracking after 60 years of service. Its structural stability, in spite of its age, is satisfactory. The headwall, maintenance platform and flashboards were apparently added to the inlet in 1937 and are in about the same condition as the box culvert.

View of Spillway Intake Structure
